# Access Compliance Report Public Rights-of-Way (Curb Ramps)

Main Street: ZINNIA\_ST Cross Street: AVENDALE\_BLV Location: SW

ADA ID: RPRK211111170323 Ramp Type: Type 4 - Parallel Initial Pass/Fail: Fail Overall Compliance: No Severity Score: 2

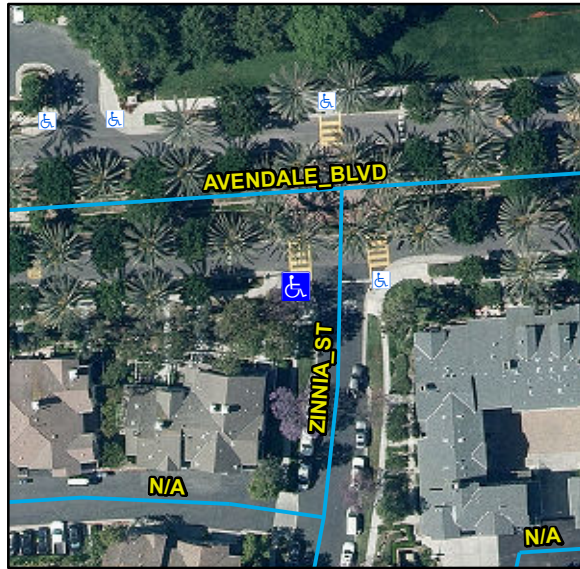
| Compliance | Description | Data | Compliance | Description | Data |
|---|---|---|---|---|---|
| No | Ramp Cross Slope LT (%) | 2.9 | No | Ramp Cross Slope RT (%) | 2.8 |
| N/A | Gutter Ponding | N/A | No | Curb Slope | 9.6 |

Remove & Replace Curb Ramp With Two New Directional Ramps or Equivalent.

R304.2.2, R204.3, R304.5.3, STD 1115
