# Access Compliance Report Public Rights-of-Way (Curb Ramps)

| Main Street: AVENDALE_BLV | | Cross Street: ZINNIA_ST | | Location: | NE |
| ADA ID: RPRK21111170822 | Ramp Type:Type 1 - Perpendicular | Initial Pass/Fail: Fail | Overall Compliance: No | Severity Score: | 15 |

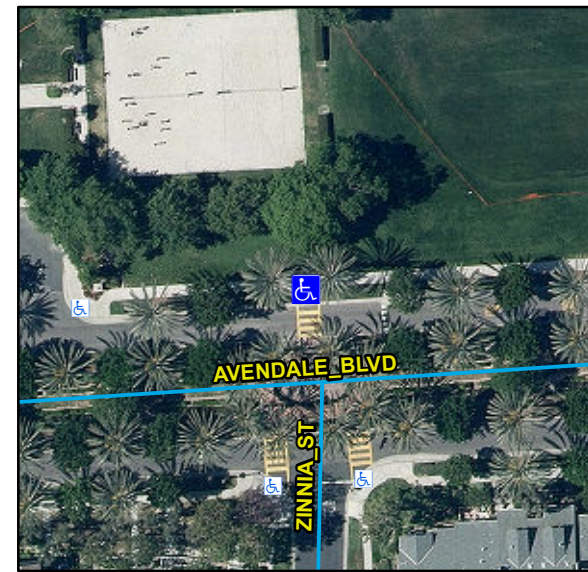
R304.2.2, R204.3, STD 1115

| Compliance | Description | Data | Compliance | Description | Data |
|---|---|---|---|---|---|
| No | Ramp Run Slope (%) | 11.9 | N/A | Flare Slope LT (%) | N/A |

Remove & Replace Entire Ramp.

Total Cost: \$ 3080
