# Access Compliance Report Public Rights-of-Way (Curb Ramps)

Main Street: N\_DAISSY\_ST Cross Street: AVENDALE\_BLVD Location: NE

ADA ID: RPRK211111171233 Ramp Type: Type 4 - Parallel Initial Pass/Fail: Fail Overall Compliance: No Severity Score: 16

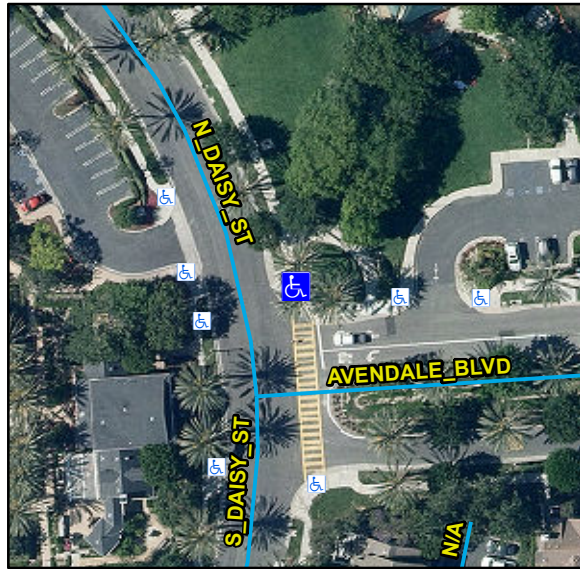
| Compliance | Description | Data | Compliance | Description | Data |
|---|---|---|---|---|---|
| No | Ramp Run Slope LT (%) | 9 | Yes | Ramp Run Slope RT (%) | 1.7 |
| No | Ramp Cross Slope LT (%) | 2.6 | No | Ramp Cross Slope RT (%) | 3.2 |

Remove & Replace Curb Ramp With Two New Directional Ramps or Equivalent.
