# Access Compliance Report Public Rights-of-Way (Curb Ramps)

Main Street: AVENDALE\_BLV D Cross Street: S\_DAI SY\_ST Location: SE

ADA ID: RPRK211111171859 Ramp Type: Type 4 - Parallel Initial Pass/Fail: Fail Overall Compliance: No Severity Score: 15

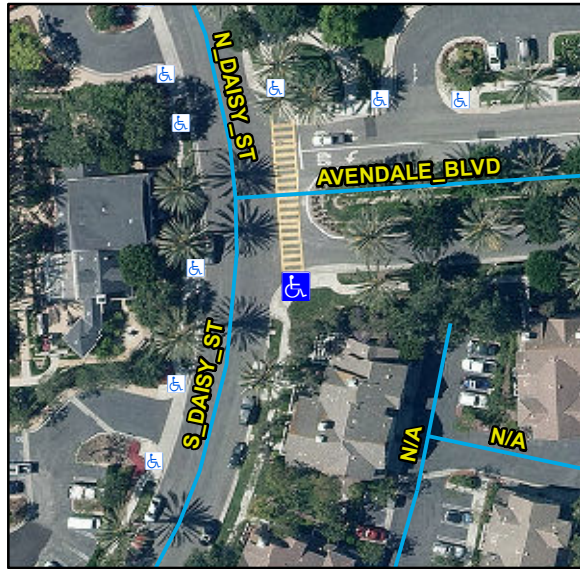
| Compliance | Description | Data | Compliance | Description | Data |
|---|---|---|---|---|---|
| No | Ramp Cross Slope LT (%) | 6.4 | No | Ramp Cross Slope RT (%) | 6.5 |

Remove & Replace Curb Ramp With Two New Directional Ramps or Equivalent.

R204.3, R304.5.3, STD 1115
