# Access Compliance Report Public Rights-of-Way (Curb Ramps)

| Main Street: S_DAISSY_ST | | Cross Street: AVENDALE_BLVD | | Location: | SW |
| ADA ID: RPRK21111172424 | Ramp Type:Type 1 - Perpendicular | Initial Pass/Fail: Pass | Overall Compliance: No | Severity Score: | 15 |

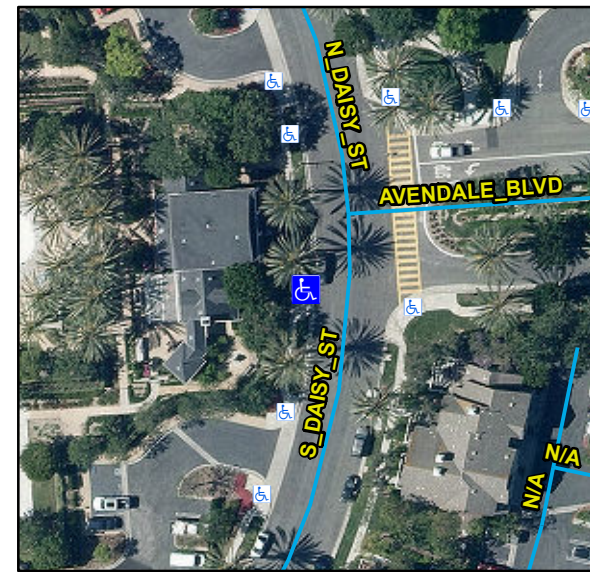
R304.2.2, R305, R304.5.4, STD 1115

Possible Solutions:

Remove & Replace Entire Ramp. Remove & Replace Gutter.

Total Cost: \$ 3332

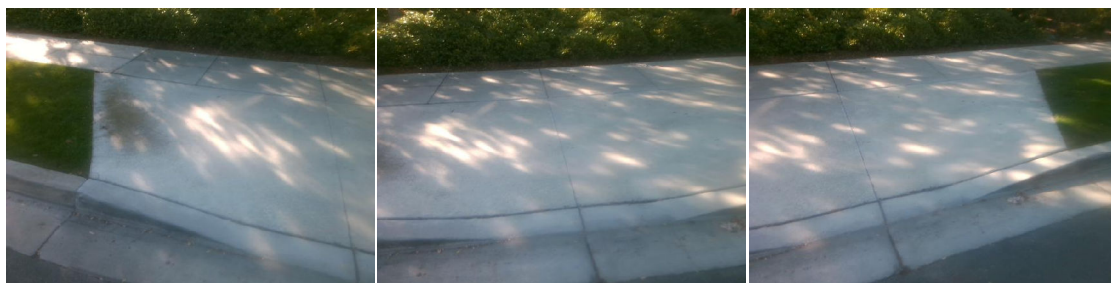
| Compliance | Description | Data | Compliance | Description | Data |
|---|---|---|---|---|---|
| Yes | Landing Cross Slope (%) | 1.8 | No | DWS Provided | No |
| Yes | Gutter Ponding | No | No | Curb Slope | 13.8 |
| No | Gutter Run Slope (%) | 7.8 | | Road Cross Slope (%) | N/A |
