# Access Compliance Report Public Rights-of-Way (Curb Ramps)

| Main Street: SIENNA_PKWY | | Cross Street: S_DAISSY_ST | | Location: | NE |
| ADA ID: RPRK211112114122 | Ramp Type: Type 4 - Parallel | Initial Pass/Fail: Fail | Overall Compliance: No | Severity Score: | 16 |

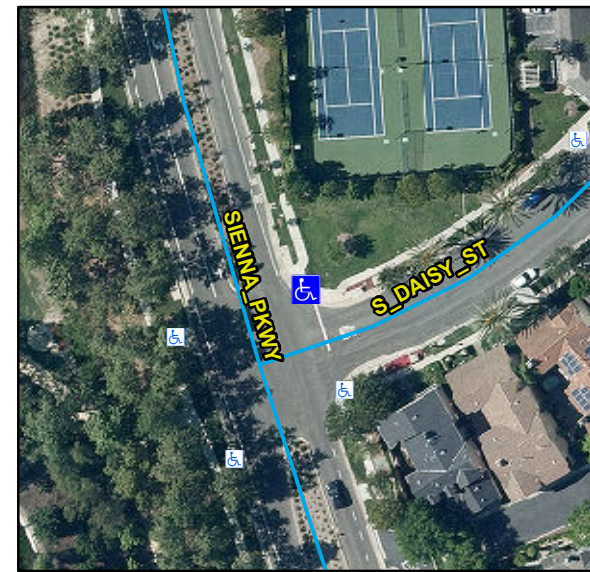
| Compliance | Description | Data | Compliance | Description | Data |
|---|---|---|---|---|---|
| No | Ramp Run Slope LT (%) | 10.1 | Yes | Ramp Run Slope RT (%) | 6.2 |
| No | Ramp Cross Slope LT (%) | 2.7 | No | Ramp Cross Slope RT (%) | 3.6 |

Possible Solutions:

**Remove & Replace Curb Ramp With Two New Directional Ramps or Equivalent.**

**R204.3, R304.3.2, R304.5.3, STD 1115**

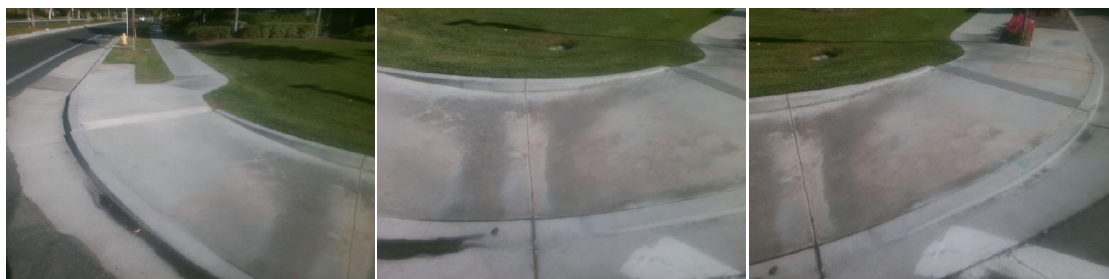
| Compliance | Description | Data | Compliance | Description | Data |
|---|---|---|---|---|---|
| N/A | Ramp Length LT (in) | 138 | N/A | Ramp Length RT (in) | 126 |
| Yes | Ramp Width LT (in) | 89 | Yes | Ramp Width RT (in) | 89 |
