# Access Compliance Report Public Rights-of-Way (Curb Ramps)

| Main Street: S_DAISSY_ST | | Cross Street: SIENNA_PKWY | | Location: | SE |
| ADA ID: RPRK211112114605 | Ramp Type: Type 4 - Parallel | Initial Pass/Fail: Fail | Overall Compliance: No | Severity Score: | 16 |

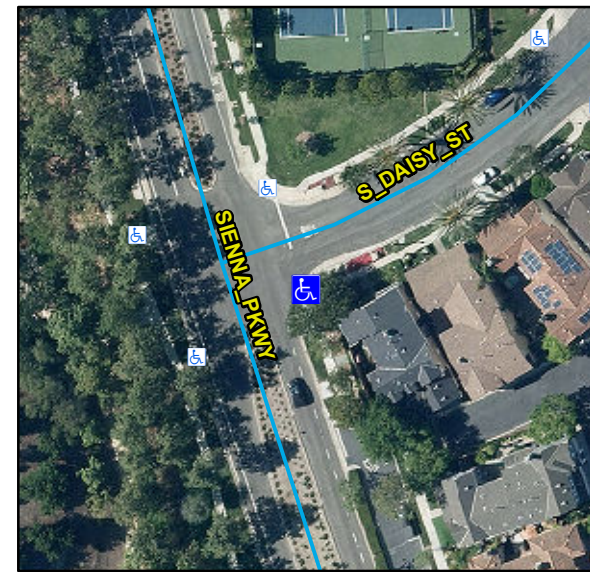
| Compliance | Description | Data | Compliance | Description | Data |
|---|---|---|---|---|---|
| No | Ramp Run Slope LT (%) | 10.9 | Yes | Ramp Run Slope RT (%) | 1.7 |
| No | Ramp Cross Slope LT (%) | 3.1 | Yes | Ramp Cross Slope RT (%) | 0.7 |

**Remove & Replace Curb Ramp With Two New Directional Ramps or Equivalent.**

**R204.3, R304.3.2, R304.5.3, STD 1115**
