# Access Compliance Report Public Rights-of-Way (Curb Ramps)

| Main Street: CLYDESDALE_DR | | Cross Street: BRYANT_CT | | Location: | NE |
| ADA ID: RPRK211112120522 | Ramp Type: Type 4 - Parallel | Initial Pass/Fail: Fail | Overall Compliance: No | Severity Score: | 15 |

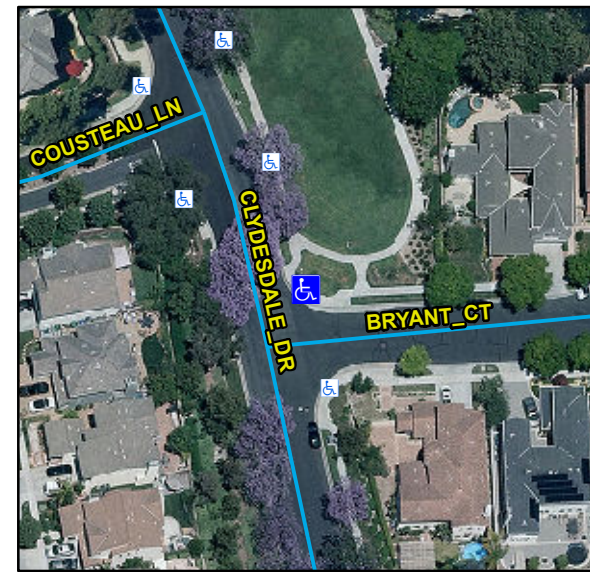
| Compliance | Description | Data | Compliance | Description | Data |
|---|---|---|---|---|---|
| No | Ramp Run Slope LT (%) | 8.9 | Yes | Ramp Run Slope RT (%) | 4.8 |

**Remove & Replace Curb Ramp With Two New Directional Ramps or Equivalent.**

**R204.3, R304.3.2, STD 1115**
