# Access Compliance Report Public Rights-of-Way (Curb Ramps)

Main Street: BRYANT\_CT Cross Street: CLYDESDALE\_DR Location: SE

ADA ID: RPRK211112120939 Ramp Type: Type 4 - Parallel Initial Pass/Fail: Fail Overall Compliance: No Severity Score: 15

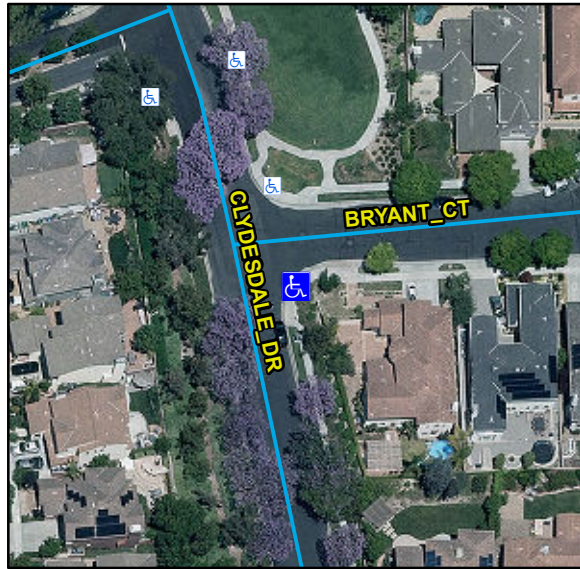
| Compliance | Description | Data | Compliance | Description | Data |
|---|---|---|---|---|---|
| No | Ramp Run Slope LT (%) | 10.2 | Yes | Ramp Run Slope RT (%) | 1.5 |

**Remove & Replace Curb Ramp With Two New Directional Ramps or Equivalent.**

**R204.3, R304.3.2, STD 1115**
