# Access Compliance Report Public Rights-of-Way (Curb Ramps)

Main Street: CLYDESDALE\_DR Cross Street: TALBOTT\_CT Location: E

ADA ID: RPRK211112121449 Ramp Type: Type 4 - Parallel Initial Pass/Fail: Pass Overall Compliance: No Severity Score: 25

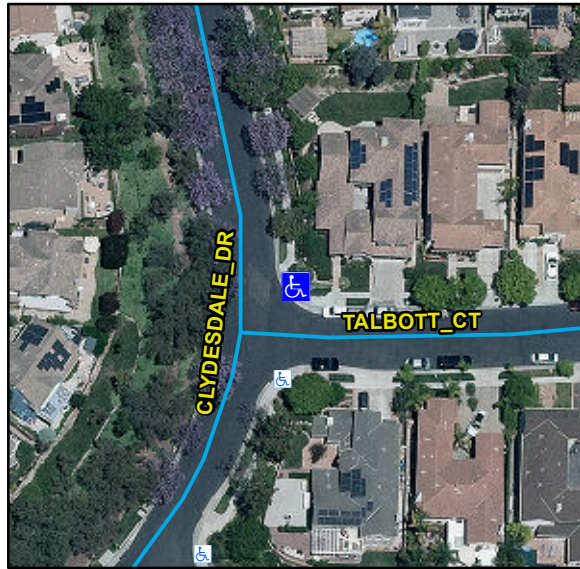
| Compliance | Description | Data | Compliance | Description | Data |
|---|---|---|---|---|---|
| N/A | Landing Present | No | No | DWS Provided | No |
| No | Landing Width (in) | N/A | N/A | DWS Length (in) | N/A |
| No | Landing Run Slope (%) | N/A | N/A | DWS Full Width | N/A |
| No | Landing Cross Slope (%) | N/A | | DWS Offset Type | N/A |
| Yes | Gutter Ponding | No | No | Curb Slope | 11.4 |
| No | Gutter Run Slope (%) | 6.9 | | Road Cross Slope (%) | 4.2 |
| Yes | Gutter Cross Slope (%) | 1.2 | No | Perpendicular Joint Present | No |

**Remove & Replace Curb Ramp With Two New Directional Ramps or Equivalent. Remove & Replace Gutter.**
