# Access Compliance Report Public Rights-of-Way (Curb Ramps)

Main Street: TALBOTT\_CT Cross Street: CLYDESDALE\_DR Location: S

ADA ID: RPRK211112122102 Ramp Type: Type 4 - Parallel Initial Pass/Fail: Pass Overall Compliance: No Severity Score: 20

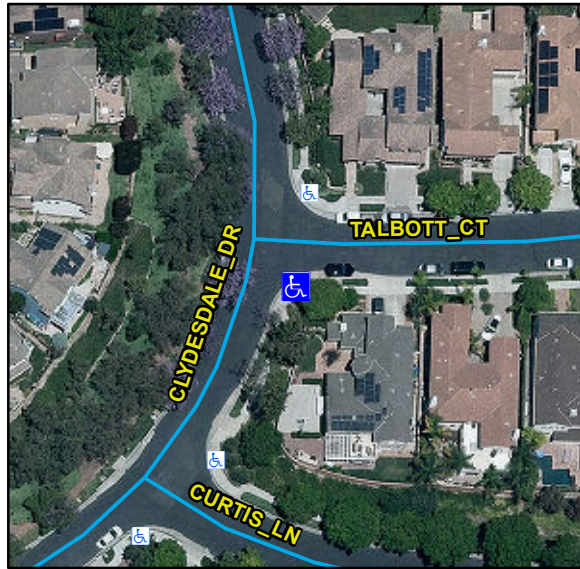
R304.2.2, R204.3, R304.2.1, R304.2.2-Perp, R304.3.2-Para, R304.5.3, R305, STD 1115

Remove & Replace Curb Ramp With Two New Directional Ramps or Equivalent.
