# Access Compliance Report Public Rights-of-Way (Curb Ramps)

Main Street: CLYDESDALE\_DR Cross Street: CURTIS\_LN Location: E

ADA ID: RPRK211112122602 Ramp Type: Type 4 - Parallel Initial Pass/Fail: Pass Overall Compliance: No Severity Score: 26

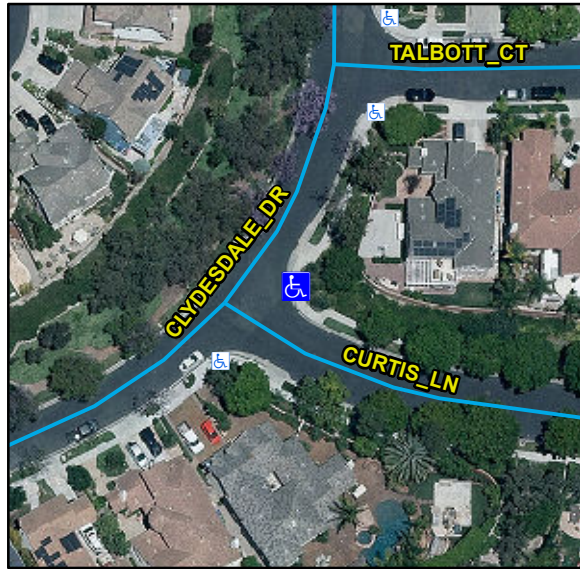
| Compliance | Description | Data | Compliance | Description | Data |
|---|---|---|---|---|---|
| No | Ramp Cross Slope LT (%) | 2.1 | Yes | Ramp Cross Slope RT (%) | 0.3 |
| No | Gutter Run Slope (%) | 9.3 | | Road Cross Slope (%) | 3 |

Remove & Replace Curb Ramp With Two New Directional Ramps or Equivalent. Remove & Replace Gutter.
