# Access Compliance Report Public Rights-of-Way (Curb Ramps)

Main Street: CURTIS\_LN Cross Street: CLYDESDALE\_DR Location: S

ADA ID: RPRK211112123059 Ramp Type: Type 4 - Parallel Initial Pass/Fail: Pass Overall Compliance: No Severity Score: 25

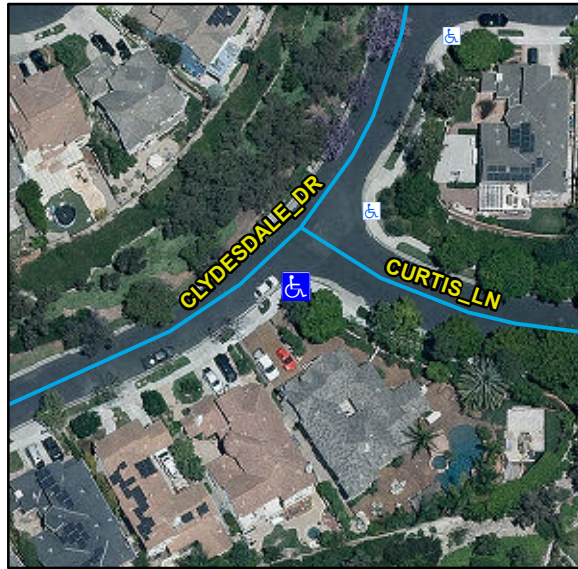
| Compliance | Description | Data | Compliance | Description | Data |
|---|---|---|---|---|---|
| N/A | Landing Present | No | No | DWS Provided | No |
| No | Landing Width (in) | N/A | N/A | DWS Length (in) | N/A |
| No | Landing Run Slope (%) | N/A | N/A | DWS Full Width | N/A |
| No | Landing Cross Slope (%) | N/A | | DWS Offset Type | N/A |
| Yes | Gutter Ponding | No | No | Curb Slope | 9.1 |
| No | Gutter Run Slope (%) | 10 | | Road Cross Slope (%) | 6.3 |

Remove & Replace Curb Ramp With Two New Directional Ramps or Equivalent. Remove & Replace Gutter.

R304.2.2, R204.3, R304.2.1, R304.2.2-Perp, R304.3.2-Para, R304.5.3, R305, R304.5.4, STD 1115
