# Access Compliance Report Public Rights-of-Way (Curb Ramps)

| Main Street: DORRANCE_DR | | Cross Street: PERCHERON_DR | | Location: | NE |
| ADA ID: RPRK211112124937 | Ramp Type: Type 4 - Parallel | Initial Pass/Fail: Fail | Overall Compliance: No | Severity Score: | 16 |

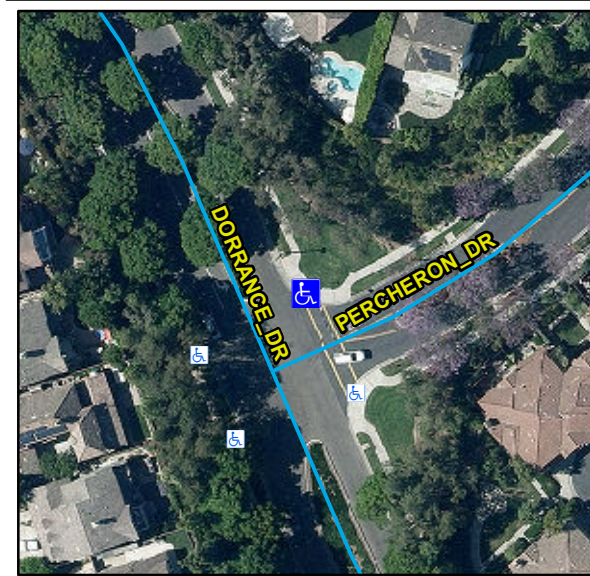
| Compliance | Description | Data | Compliance | Description | Data |
|---|---|---|---|---|---|
| Yes | Ramp Run Slope LT (%) | 11.2 | Yes | Ramp Run Slope RT (%) | 0.2 |
| Yes | Ramp Cross Slope LT (%) | 0.5 | No | Ramp Cross Slope RT (%) | 2.3 |

**Remove & Replace Curb Ramp With Two New Directional Ramps or Equivalent.**

**R204.3, R304.5.3, STD 1115**

Total Cost: \$ 4000
