# Access Compliance Report Public Rights-of-Way (Curb Ramps)

| Main Street: PERCHERON_DR | | Cross Street: DORRANCE_DR | | Location: | SE |
| ADA ID: RPRK211112125459 | Ramp Type: Type 4 - Parallel | Initial Pass/Fail: Fail | Overall Compliance: No | Severity Score: | 2 |

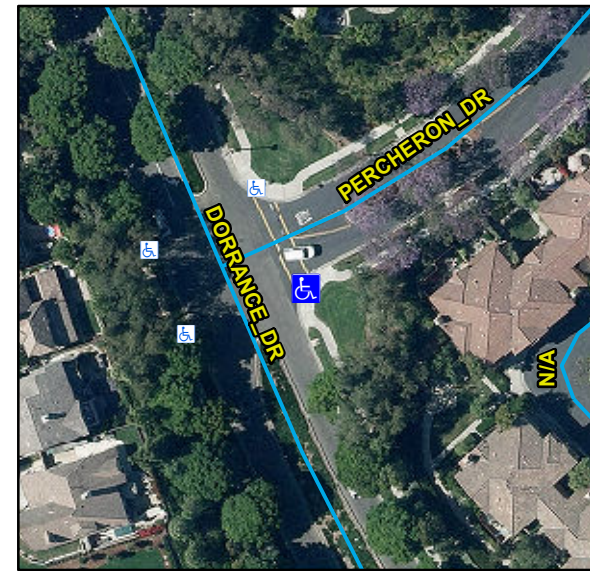
| Compliance | Description | Data | Compliance | Description | Data |
|---|---|---|---|---|---|
| Yes | Ramp Cross Slope LT (%) | 1 | No | Ramp Cross Slope RT (%) | 2.1 |
| N/A | Gutter Ponding | N/A | No | Curb Slope | 14.7 |
| N/A | Gutter Cross Slope (%) | N/A | No | Perpendicular Joint Present | No |

**Remove & Replace Curb Ramp With Two New Directional Ramps or Equivalent.**

**R304.2.2, R204.3, R304.5.3, STD 1115**

Total Cost: \$ 4000
