# Access Compliance Report Public Rights-of-Way (Curb Ramps)

Main Street: DORRANCE\_DR Cross Street: PERCHERON\_DR Location: NW

ADA ID: RPRK211112130337 Ramp Type: Type 1 - Perpendicular Initial Pass/Fail: Fail Overall Compliance: No Severity Score: 16

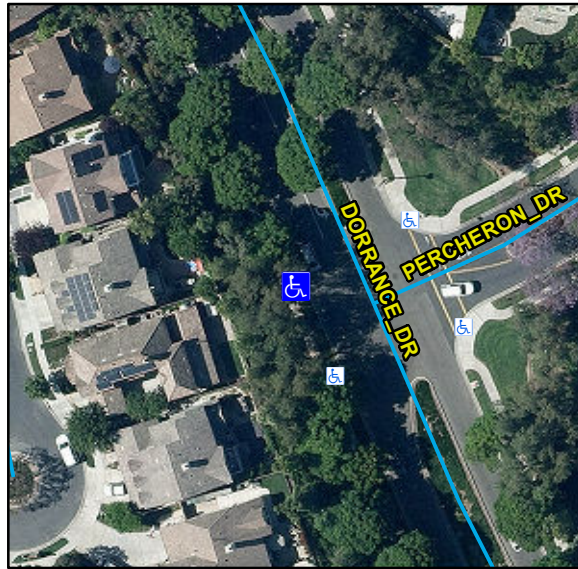
| Compliance | Description | Data | Compliance | Description | Data |
|---|---|---|---|---|---|
| No | Ramp Run Slope (%) | 10.1 | N/A | Flare Slope LT (%) | N/A |

Remove & Replace Entire Ramp.

R204.3, R304.2.2, STD 1115
