# Access Compliance Report Public Rights-of-Way (Curb Ramps)

Main Street: PERCHERON\_DR Cross Street: DE\_LEON\_LN Location: W

ADA ID: RPRK211112143402 Ramp Type: Type 4 - Parallel Initial Pass/Fail: Fail Overall Compliance: No Severity Score: 2

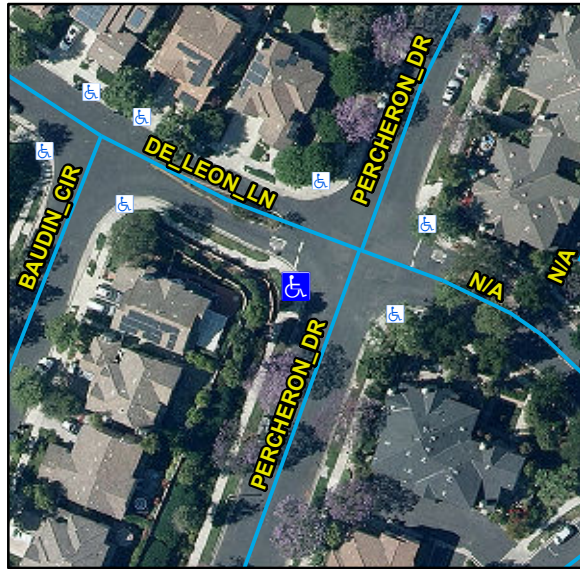
| Compliance | Description | Data | Compliance | Description | Data |
|---|---|---|---|---|---|
| No | Ramp Cross Slope LT (%) | 2.6 | Yes | Ramp Cross Slope RT (%) | 1 |
| N/A | Gutter Ponding | N/A | No | Curb Slope | 12 |
| N/A | Gutter Cross Slope (%) | N/A | No | Perpendicular Joint Present | No |

Remove & Replace Curb Ramp With Two New Directional Ramps or Equivalent.

R304.2.2, R204.3, R304.5.3, STD 1115
