# Access Compliance Report Public Rights-of-Way (Curb Ramps)

Main Street: DE\_LEON\_LN Cross Street: BAUDIN\_CIR Location: S

ADA ID: RPRK211112143823 Ramp Type: Type 4 - Parallel Initial Pass/Fail: Pass Overall Compliance: No Severity Score: 26

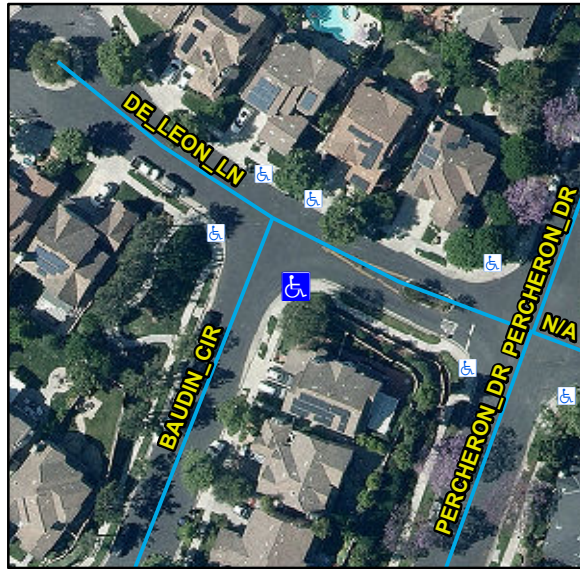
| Compliance | Description | Data | Compliance | Description | Data |
|---|---|---|---|---|---|
| No | Landing Width (in) | N/A | N/A | DWS Length (in) | N/A |
| No | Landing Run Slope (%) | N/A | N/A | DWS Full Width | N/A |
| No | Landing Cross Slope (%) | N/A | | DWS Offset Type | N/A |
| No | Gutter Run Slope (%) | 11.1 | | Road Cross Slope (%) | 3.5 |
| No | Gutter Cross Slope (%) | 4.7 | No | Perpendicular Joint Present | No |

Remove & Replace Curb Ramp With Two New Directional Ramps or Equivalent. Remove & Replace Gutter.
