# Access Compliance Report Public Rights-of-Way (Curb Ramps)

Main Street: BAUDIN\_CIR Cross Street: DE\_LEON\_LN Location: W

ADA ID: RPRK211112144204 Ramp Type: Type 4 - Parallel Initial Pass/Fail: Fail Overall Compliance: No Severity Score: 32

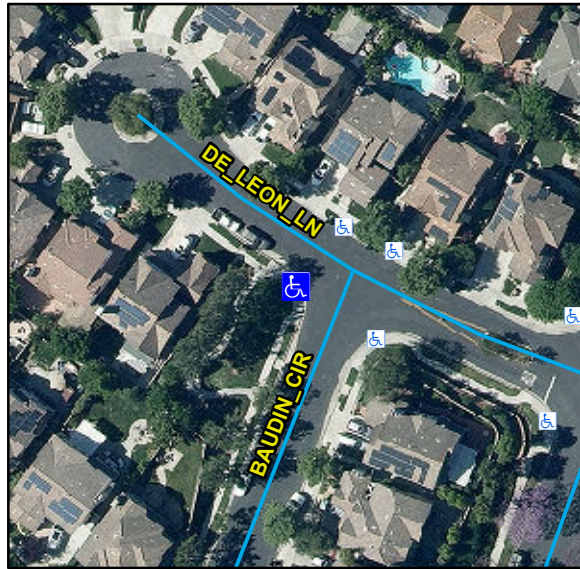
| Compliance | Description | Data | Compliance | Description | Data |
|---|---|---|---|---|---|
| Yes | Ramp Run Slope LT (%) | 1.1 | No | Ramp Run Slope RT (%) | 12.5 |
| No | Ramp Cross Slope LT (%) | 2.1 | Yes | Ramp Cross Slope RT (%) | 0.5 |

Remove & Replace Curb Ramp With Two New Directional Ramps or Equivalent.

R204.3, R304.5.3, R304.3.2, STD 1115
