# Access Compliance Report Public Rights-of-Way (Curb Ramps)

| Main Street: PERCHERON_DR | | Cross Street: N/A | | Location: | E |
| ADA ID: RPRK211112144837 | Ramp Type: Type 4 - Parallel | Initial Pass/Fail: Fail | Overall Compliance: No | Severity Score: | 2 |

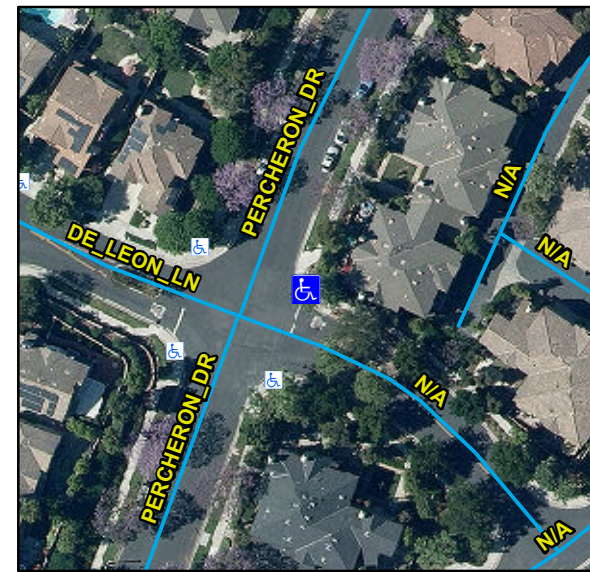
| Compliance | Description | Data | Compliance | Description | Data |
|---|---|---|---|---|---|
| No | Ramp Cross Slope LT (%) | 2.4 | Yes | Ramp Cross Slope RT (%) | 0.7 |

**Remove & Replace Curb Ramp With Two New Directional Ramps or Equivalent.**

**R204.3, R304.5.3, STD 1115**

Total Cost: \$ 4000
