# Access Compliance Report Public Rights-of-Way (Curb Ramps)

| Main Street: PERCHERON_DR | | Cross Street: N/A | | Location: | S |
| ADA ID: RPRK211112145105 | Ramp Type: Type 4 - Parallel | Initial Pass/Fail: Fail | Overall Compliance: No | Severity Score: | 2 |

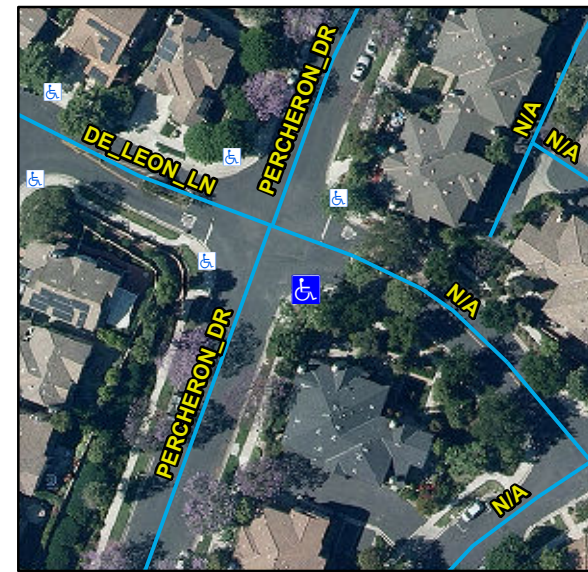
| Compliance | Description | Data | Compliance | Description | Data |
|---|---|---|---|---|---|
| No | Ramp Cross Slope LT (%) | 3.8 | Yes | Ramp Cross Slope RT (%) | 1.7 |

Possible Solutions:

**Remove & Replace Curb Ramp With Two New Directional Ramps or Equivalent.**

**R204.3, R304.5.3, STD 1115**
