# Access Compliance Report Public Rights-of-Way (Curb Ramps)

Main Street: PERCHERON\_DR Cross Street: SYLVANOAK\_WAY Location: NW

ADA ID: RPRK211112145619 Ramp Type: Type 4 - Parallel Initial Pass/Fail: Fail Overall Compliance: No Severity Score: 2

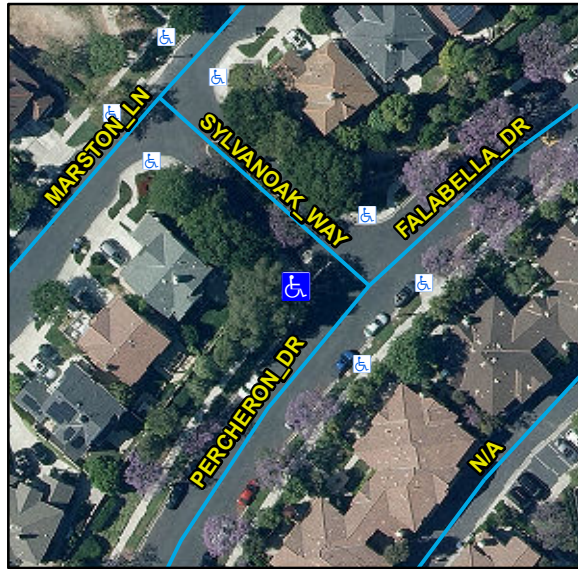
| Compliance | Description | Data | Compliance | Description | Data |
|---|---|---|---|---|---|
| No | Ramp Cross Slope LT (%) | 3.9 | Yes | Ramp Cross Slope RT (%) | 2 |
| N/A | Gutter Ponding | N/A | No | Curb Slope | 13 |
| N/A | Gutter Cross Slope (%) | N/A | No | Perpendicular Joint Present | No |

Remove & Replace Curb Ramp With Two New Directional Ramps or Equivalent.

R304.2.2, R204.3, R304.5.3, STD 1115
