# Access Compliance Report Public Rights-of-Way (Curb Ramps)

Main Street: SYLVANOAK\_WAY Cross Street: FALABELLA\_DR Location: NE

ADA ID: RPRK211112145844 Ramp Type: Type 4 - Parallel Initial Pass/Fail: Fail Overall Compliance: No Severity Score: 2

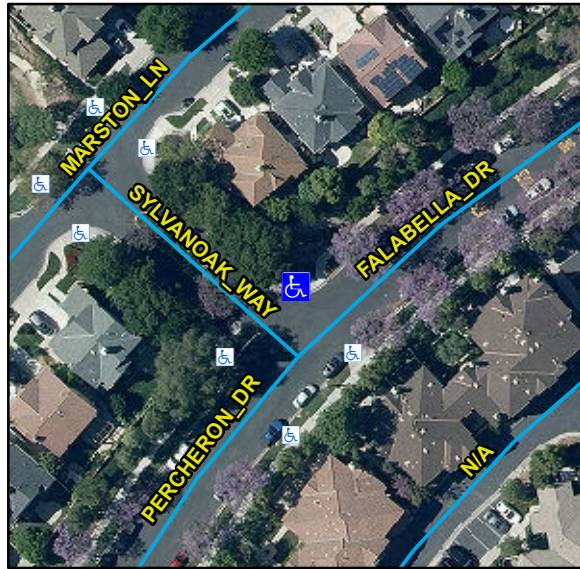
| Compliance | Description | Data | Compliance | Description | Data |
|---|---|---|---|---|---|
| Yes | Ramp Cross Slope LT (%) | 1.7 | No | Ramp Cross Slope RT (%) | 2.7 |
| N/A | Gutter Ponding | N/A | No | Curb Slope | 19 |
| N/A | Gutter Cross Slope (%) | N/A | No | Perpendicular Joint Present | No |

Remove & Replace Curb Ramp With Two New Directional Ramps or Equivalent.

R304.2.2, R204.3, R304.5.3, STD 1115

Total Cost: \$ 4000
