# Access Compliance Report Public Rights-of-Way (Curb Ramps)

Main Street: FALABELLA\_DR Cross Street: SYLVANOAK\_WAY Location: SE

ADA ID: RPRK211112150202 Ramp Type: Type 1 - Perpendicular Initial Pass/Fail: Pass Overall Compliance: No Severity Score: 15

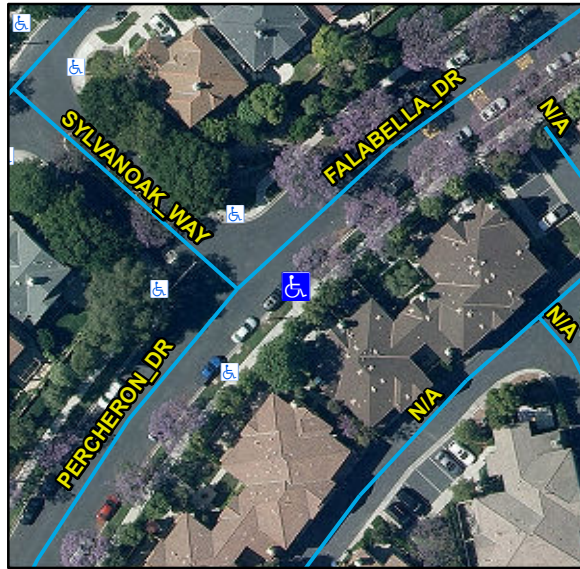
| Compliance | Description | Data | Compliance | Description | Data |
|---|---|---|---|---|---|
| No | Landing Run Slope (%) | 2.1 | N/A | Flare Traversable RT | No |
| Yes | Landing Cross Slope (%) | 0.6 | No | DWS Provided | No |
| No | Gutter Run Slope (%) | 9.1 | | Road Cross Slope (%) | N/A |
| No | Gutter Cross Slope (%) | 2.8 | | | |

Remove & Replace Entire Ramp. Remove & Replace Gutter.
