# Access Compliance Report Public Rights-of-Way (Curb Ramps)

Main Street: FALABELLA\_DR Cross Street: HANOVERIAN\_WAY Location: NW

ADA ID: RPRK211112150633 Ramp Type: Type 4 - Parallel Initial Pass/Fail: Fail Overall Compliance: No Severity Score: 16

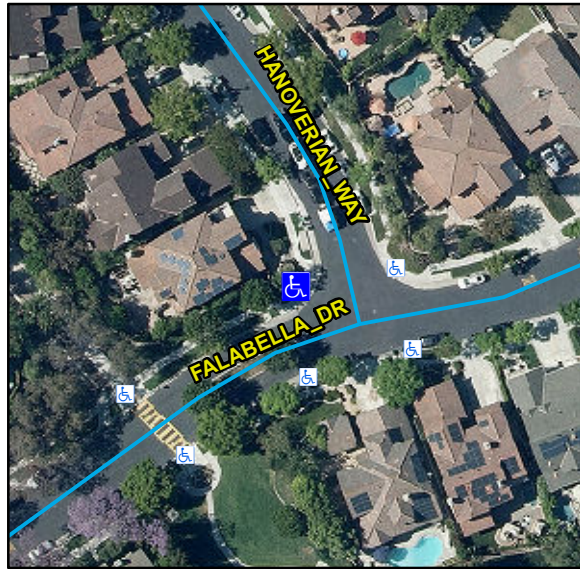
| Compliance | Description | Data | Compliance | Description | Data |
|---|---|---|---|---|---|
| Yes | Ramp Run Slope LT (%) | 2.1 | No | Ramp Run Slope RT (%) | 9.7 |
| Yes | Ramp Cross Slope LT (%) | 1.9 | No | Ramp Cross Slope RT (%) | 2.6 |

**Remove & Replace Curb Ramp With Two New Directional Ramps or Equivalent.**
