# Access Compliance Report Public Rights-of-Way (Curb Ramps)

| Main Street: ROANOKE_DR | | Cross Street: O_NEILL_DR | | Location: | S |
| ADA ID: RPRK211115112424 | Ramp Type: Type 4 - Parallel | Initial Pass/Fail: Fail | Overall Compliance: No | Severity Score: | 16 |

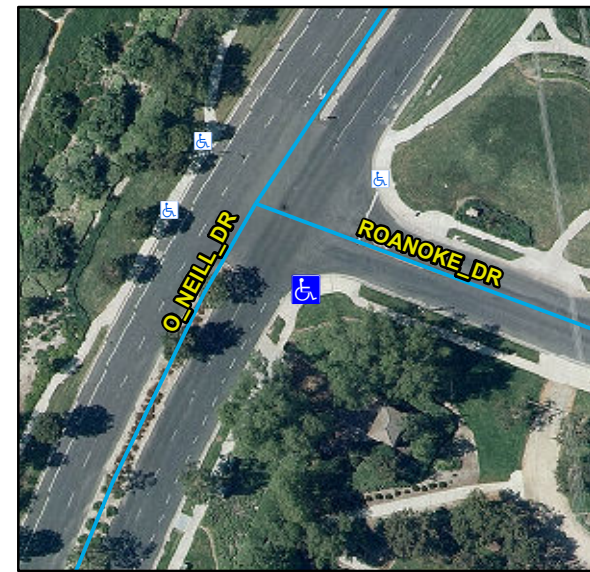
| Compliance | Description | Data | Compliance | Description | Data |
|---|---|---|---|---|---|
| No | Ramp Run Slope LT (%) | 11.2 | Yes | Ramp Run Slope RT (%) | 1.7 |
| Yes | Ramp Cross Slope LT (%) | 1.5 | No | Ramp Cross Slope RT (%) | 2.3 |

**Remove & Replace Curb Ramp With Two New Directional Ramps or Equivalent.**

**R204.3, R304.3.2, R304.5.3, STD 1115**
