# Access Compliance Report Public Rights-of-Way (Curb Ramps)

| Main Street: O_NEILL_DR | | Cross Street: ROANOKE_DR | | Location: | E |
| ADA ID: RPRK211115112852 | Ramp Type: Type 4 - Parallel | Initial Pass/Fail: Fail | Overall Compliance: No | Severity Score: | 30 |

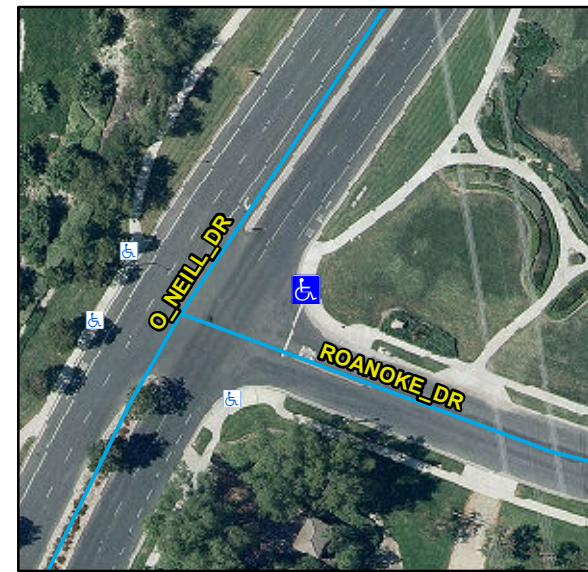
| Compliance | Description | Data | Compliance | Description | Data |
|---|---|---|---|---|---|
| No | Ramp Run Slope LT (%) | 12.1 | Yes | Ramp Run Slope RT (%) | 1.7 |

**Remove & Replace Curb Ramp With Two New Directional Ramps or Equivalent.**

**R204.3, R304.3.2, STD 1115**

Total Cost: \$ 4000

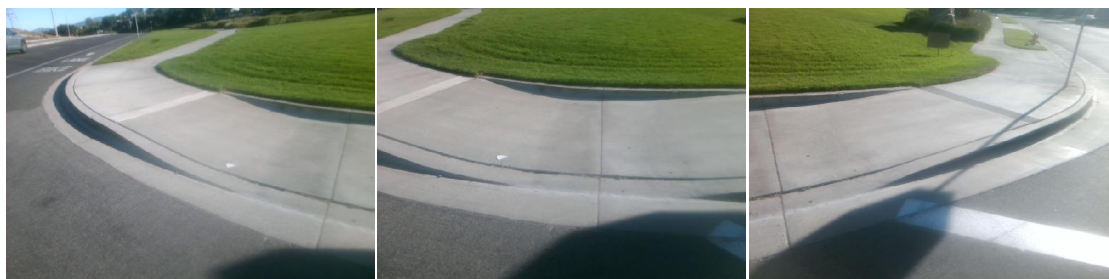
| Compliance | Description | Data | Compliance | Description | Data |
|---|---|---|---|---|---|
| N/A | Ramp Length LT (in) | 112 | N/A | Ramp Length RT (in) | 117 |
| Yes | Ramp Width LT (in) | 88 | Yes | Ramp Width RT (in) | 88 |
| Yes | Ramp Cross Slope LT (%) | 1.5 | Yes | Ramp Cross Slope RT (%) | 0.7 |
