# Access Compliance Report Public Rights-of-Way (Curb Ramps)

| Main Street: O_NEILL_DR | | Cross Street: ROANOKE_DR | | Location: | W |
| ADA ID: RPRK211115113132 | Ramp Type: Type 4 - Parallel | Initial Pass/Fail: Fail | Overall Compliance: No | Severity Score: | 16 |

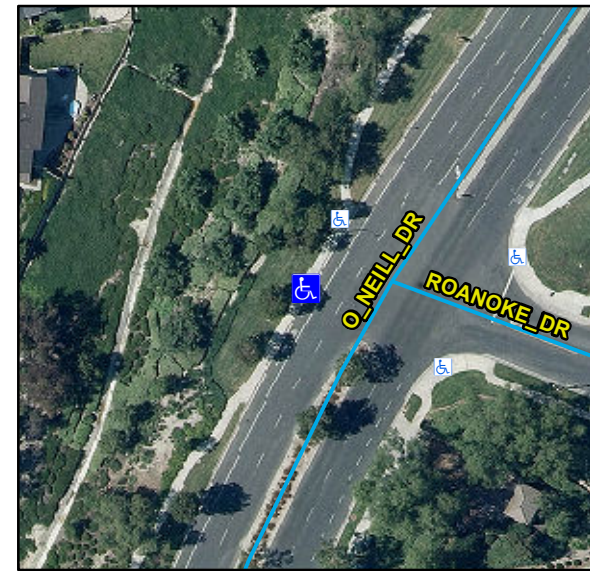
| Compliance | Description | Data | Compliance | Description | Data |
|---|---|---|---|---|---|
| Yes | Ramp Run Slope LT (%) | 2.9 | No | Ramp Run Slope RT (%) | 9.4 |
| No | Ramp Cross Slope LT (%) | 2.3 | Yes | Ramp Cross Slope RT (%) | 1.3 |

**Remove & Replace Entire Ramp.**

**R204.3, R304.5.3, R304.3.2, STD 1115**

Total Cost: \$ 2000
