# Access Compliance Report Public Rights-of-Way (Curb Ramps)

| Main Street: CHARDONNAY_DR | | Cross Street: ROANOKE_DR | | Location: | SW |
| ADA ID: RPRK211115113423 | Ramp Type: Type 4 - Parallel | Initial Pass/Fail: Fail | Overall Compliance: No | Severity Score: | 15 |

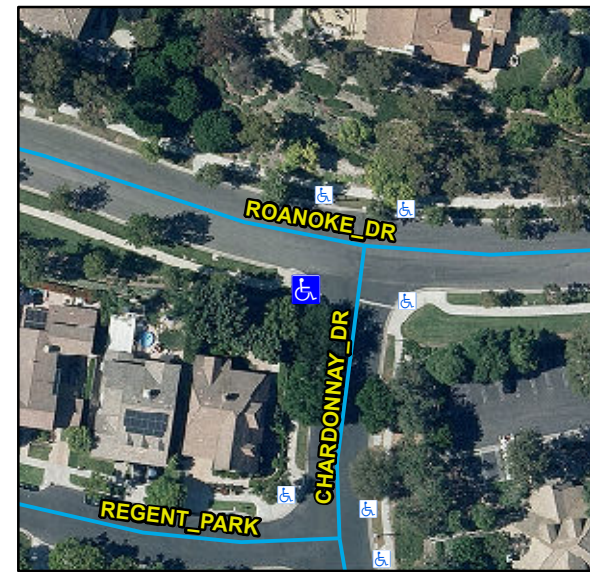
| Compliance | Description | Data | Compliance | Description | Data |
|---|---|---|---|---|---|
| No | Ramp Run Slope LT (%) | 11 | Yes | Ramp Run Slope RT (%) | 0.3 |

**Remove & Replace Curb Ramp With Two New Directional Ramps or Equivalent.**

**R204.3, R304.3.2, STD 1115**

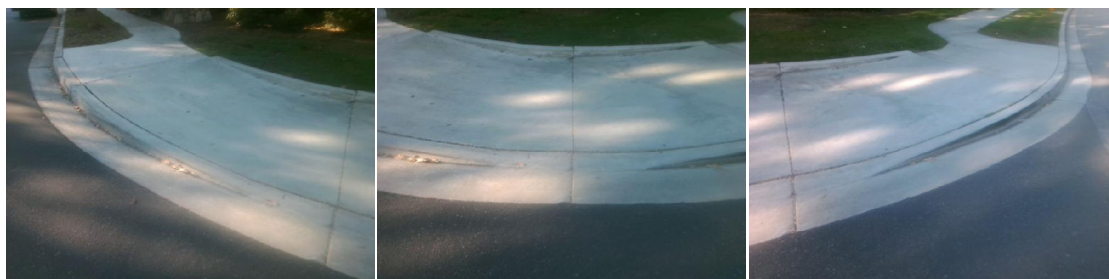
| Compliance | Description | Data | Compliance | Description | Data |
|---|---|---|---|---|---|
| N/A | Ramp Length LT (in) | 129 | N/A | Ramp Length RT (in) | 134 |
| Yes | Ramp Width LT (in) | 95 | Yes | Ramp Width RT (in) | 95 |
| Yes | Ramp Cross Slope LT (%) | 0.7 | Yes | Ramp Cross Slope RT (%) | 1.6 |
