# Access Compliance Report Public Rights-of-Way (Curb Ramps)

Main Street: ST\_IVES\_WAY Cross Street: DORRANCE\_DR Location: W

ADA ID: RPRK211115114226 Ramp Type: Type 4 - Parallel Initial Pass/Fail: Fail Overall Compliance: No Severity Score: 2

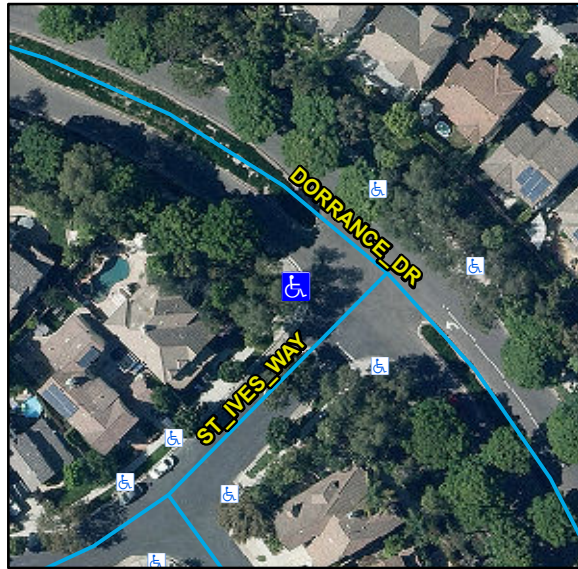
| Compliance | Description | Data | Compliance | Description | Data |
|---|---|---|---|---|---|
| Yes | Ramp Run Slope LT (%) | 2.7 | Yes | Ramp Run Slope RT (%) | 5.2 |
| No | Ramp Cross Slope LT (%) | 4.6 | No | Ramp Cross Slope RT (%) | 2.8 |

**Remove & Replace Curb Ramp With Two New Directional Ramps or Equivalent.**
