# Access Compliance Report Public Rights-of-Way (Curb Ramps)

| Main Street: DORRANCE_DR | | Cross Street: ST_IVES_WAY | | Location: | SW |
| ADA ID: RPRK211115114436 | Ramp Type: Type 4 - Parallel | Initial Pass/Fail: Pass | Overall Compliance: No | Severity Score: | 30 |

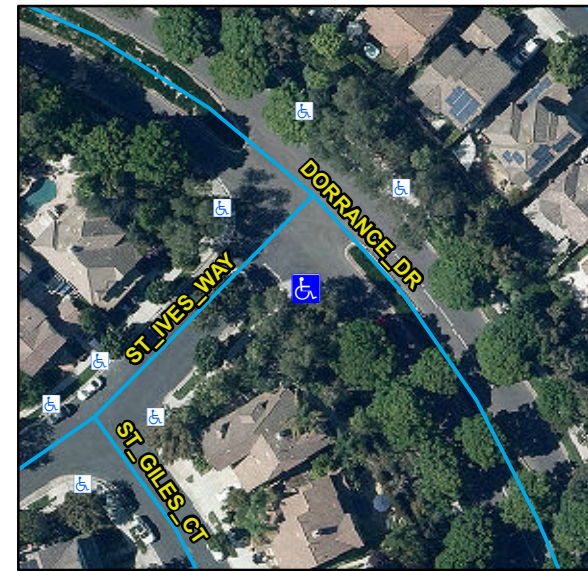
| Compliance | Description | Data | Compliance | Description | Data |
|---|---|---|---|---|---|
| Yes | Ramp Run Slope LT (%) | 4.2 | Yes | Ramp Run Slope RT (%) | 5.1 |
| N/A | Landing Present | No | No | DWS Provided | No |
| No | Landing Width (in) | N/A | N/A | DWS Length (in) | N/A |
| No | Landing Run Slope (%) | N/A | N/A | DWS Full Width | N/A |
| No | Landing Cross Slope (%) | N/A | | DWS Offset Type | N/A |
| No | Gutter Lip Height (in) | 1.5 | | Road Run Slope (%) | 1.1 |

**Remove & Replace Curb Ramp With Two New Directional Ramps or Equivalent. Grind Gutter Lip.**

**R204.3, R304.2.1, R304.2.2-Perp, R304.3.2-Para, R304.5.3, R305, R302.7.2, STD 1115**

Total Cost: \$ 4150
