# Access Compliance Report Public Rights-of-Way (Curb Ramps)

| Main Street: DORRANCE_DR | | Cross Street: DORRANCE_DR | | Location: | E |
| ADA ID: RPRK211115114659 | Ramp Type:Type 1 - Perpendicular | Initial Pass/Fail: Fail | Overall Compliance: No | Severity Score: | 15 |

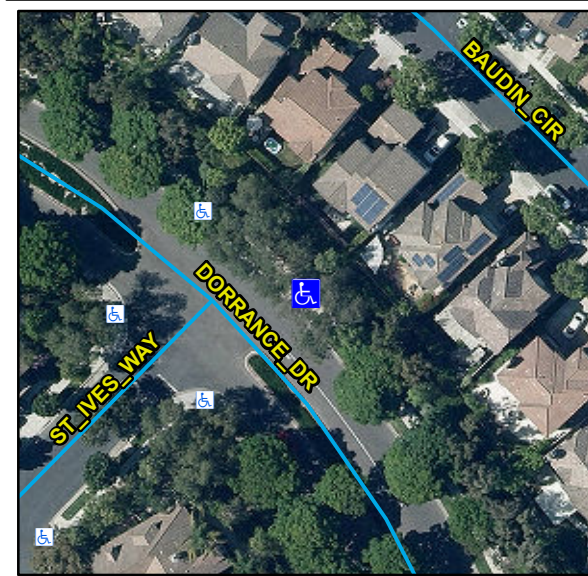
R304.2.2, R204.3, STD 1115

| Compliance | Description | Data | Compliance | Description | Data |
|---|---|---|---|---|---|
| No | Ramp Run Slope (%) | 10.8 | N/A | Flare Slope LT (%) | N/A |
| N/A | Gutter Ponding | N/A | No | Curb Slope | 14.4 |

Possible Solutions:

Remove & Replace Entire Ramp.

Total Cost: \$ 3080
