# Access Compliance Report Public Rights-of-Way (Curb Ramps)

Main Street: ST\_IVES\_WAY Cross Street: ST\_GILES\_CT Location: SE

ADA ID: RPRK211115114917 Ramp Type: Type 4 - Parallel Initial Pass/Fail: Fail Overall Compliance: No Severity Score: 15

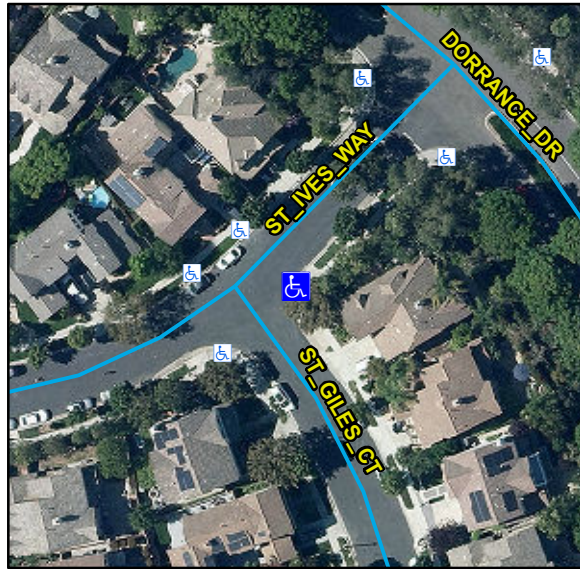
| Compliance | Description | Data | Compliance | Description | Data |
|---|---|---|---|---|---|
| Yes | Ramp Run Slope LT (%) | 4 | No | Ramp Run Slope RT (%) | 9.3 |

Remove & Replace Curb Ramp With Two New Directional Ramps or Equivalent.

R204.3, R304.3.2, STD 1115
