# Access Compliance Report Public Rights-of-Way (Curb Ramps)

Main Street: ST\_GILES\_CT Cross Street: ST\_IVES\_WAY Location: SW

ADA ID: RPRK211115115116 Ramp Type: Type 4 - Parallel Initial Pass/Fail: Pass Overall Compliance: No Severity Score: 20

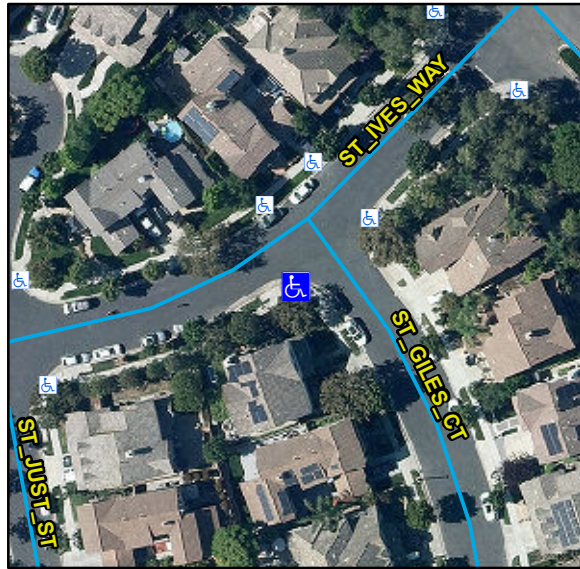
| Compliance | Description | Data | Compliance | Description | Data |
|---|---|---|---|---|---|
| N/A | Landing Present | No | No | DWS Provided | No |
| No | Landing Width (in) | N/A | N/A | DWS Length (in) | N/A |
| No | Landing Run Slope (%) | N/A | N/A | DWS Full Width | N/A |
| No | Landing Cross Slope (%) | N/A | | DWS Offset Type | N/A |
| Yes | Gutter Cross Slope (%) | 1.1 | No | Perpendicular Joint Present | No |

Remove & Replace Curb Ramp With Two New Directional Ramps or Equivalent.

R204.3, R304.2.1, R304.2.2-Perp, R304.3.2-Para, R304.5.3, R305, STD 1115

Total Cost: \$ 4000
