# Access Compliance Report Public Rights-of-Way (Curb Ramps)

Main Street: ST\_IVES\_WAY Cross Street: ST\_JUST\_ST Location: SE

ADA ID: RPRK211115115342 Ramp Type: Type 4 - Parallel Initial Pass/Fail: Pass Overall Compliance: No Severity Score: 25

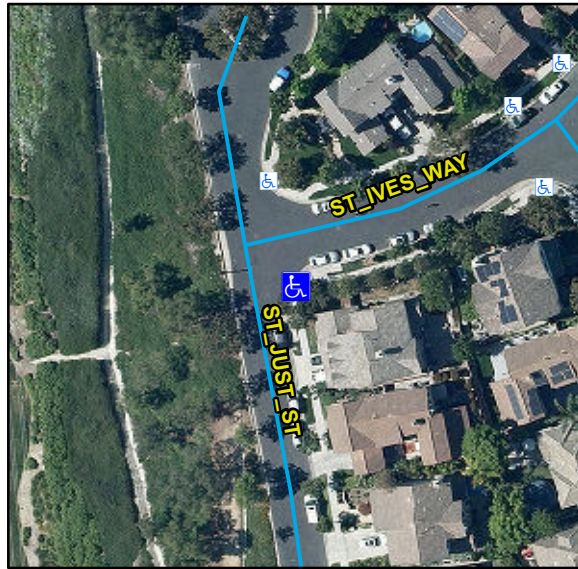
R204.3, R304.2.1, R304.2.2-Perp, R304.3.2-Para, R304.5.3, R305, R304.5.4, STD 1115

Remove & Replace Curb Ramp With Two New Directional Ramps or Equivalent. Remove & Replace Gutter.
