# Access Compliance Report Public Rights-of-Way (Curb Ramps)

Main Street: ST\_JUST\_ST Cross Street: ST\_IVES\_WAY Location: NE

ADA ID: RPRK211115115603 Ramp Type: Type 4 - Parallel Initial Pass/Fail: Fail Overall Compliance: No Severity Score: 2

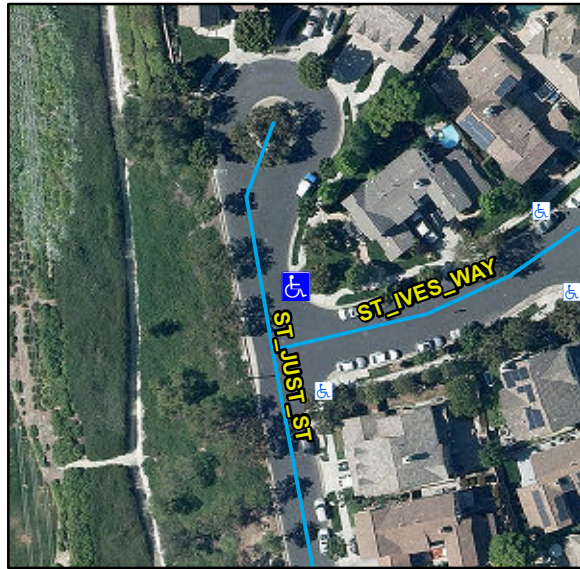
| Compliance | Description | Data | Compliance | Description | Data |
|---|---|---|---|---|---|
| No | Ramp Cross Slope LT (%) | 2.1 | Yes | Ramp Cross Slope RT (%) | 0.2 |

Remove & Replace Curb Ramp With Two New Directional Ramps or Equivalent.

R204.3, R304.5.3, STD 1115

Total Cost: \$ 4000
