# Access Compliance Report Public Rights-of-Way (Curb Ramps)

| Main Street: BAINBRIDGE_AVE | | Cross Street: ROYCROFT_CT | | Location: | SE |
| ADA ID: RPRK211115120337 | Ramp Type: Type 4 - Parallel | Initial Pass/Fail: Fail | Overall Compliance: No | Severity Score: | 2 |

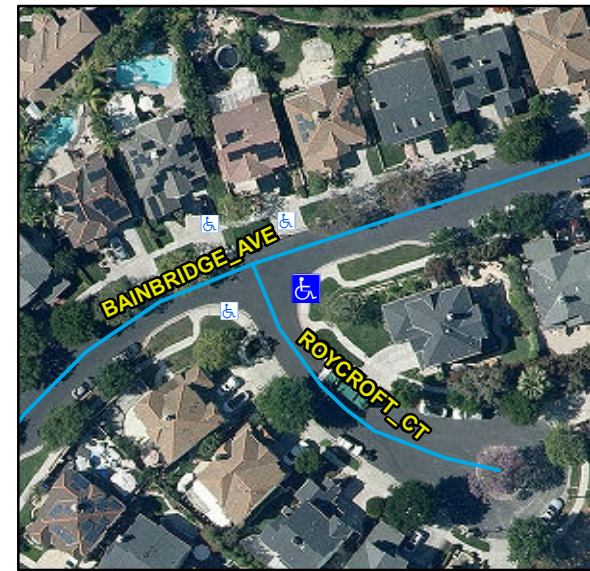
| Compliance | Description | Data | Compliance | Description | Data |
|---|---|---|---|---|---|
| No | Ramp Cross Slope LT (%) | 2.2 | No | Ramp Cross Slope RT (%) | 3.6 |

**Remove & Replace Curb Ramp With Two New Directional Ramps or Equivalent.**

Total Cost: \$ 4000
