# Access Compliance Report Public Rights-of-Way (Curb Ramps)

| Main Street: BAINBRIDGE_AVE | | Cross Street: WHIDBEY_DR | | Location: | SE |
| ADA ID: RPRK211115120901 | Ramp Type: Type 4 - Parallel | Initial Pass/Fail: Pass | Overall Compliance: No | Severity Score: | 20 |

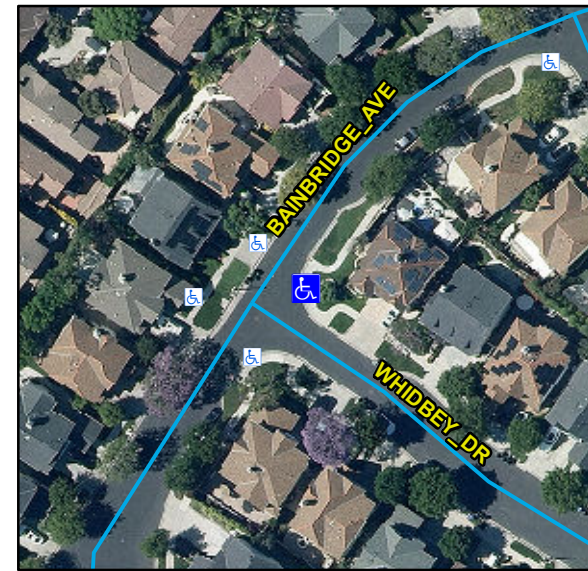
| Compliance | Description | Data | Compliance | Description | Data |
|---|---|---|---|---|---|
| N/A | Landing Present | No | No | DWS Provided | No |
| No | Landing Width (in) | N/A | N/A | DWS Length (in) | N/A |
| No | Landing Run Slope (%) | N/A | N/A | DWS Full Width | N/A |
| No | Landing Cross Slope (%) | N/A | | DWS Offset Type | N/A |

**Remove & Replace Curb Ramp With Two New Directional Ramps or Equivalent.**

**R204.3, R304.2.1, R304.2.2-Perp, R304.3.2-Para, R304.5.3, R305, STD 1115**

Total Cost: \$ 4000

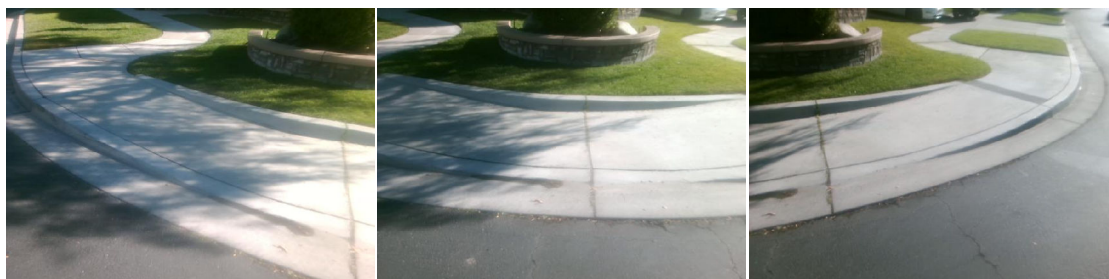
| Compliance | Description | Data | Compliance | Description | Data |
|---|---|---|---|---|---|
| N/A | Ramp Length LT (in) | 137 | N/A | Ramp Length RT (in) | 113 |
| Yes | Ramp Width LT (in) | 52 | Yes | Ramp Width RT (in) | 52 |
| Yes | Ramp Run Slope LT (%) | 6.8 | Yes | Ramp Run Slope RT (%) | 2.5 |
| Yes | Ramp Cross Slope LT (%) | 0.8 | Yes | Ramp Cross Slope RT (%) | 1.4 |
