# Access Compliance Report Public Rights-of-Way (Curb Ramps)

Main Street: WHIDBEY\_DR Cross Street: BAINBRIDGE\_AVE Location: SW

ADA ID: RPRK2111151212 Ramp Type: Type 4 - Parallel Initial Pass/Fail: Pass Overall Compliance: No Severity Score: 26

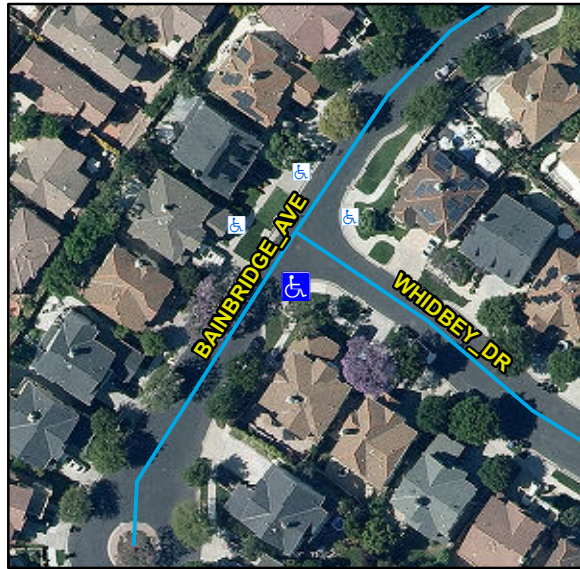
| Compliance | Description | Data | Compliance | Description | Data |
|---|---|---|---|---|---|
| No | Ramp Cross Slope LT (%) | 2.6 | Yes | Ramp Cross Slope RT (%) | 1.2 |
| No | Gutter Ponding | Yes | Yes | Curb Slope | 0.7 |
| No | Gutter Run Slope (%) | 5.5 | | Road Cross Slope (%) | 1.7 |

Remove & Replace Curb Ramp With Two New Directional Ramps or Equivalent. Remove & Replace Gutter.
