# Access Compliance Report Public Rights-of-Way (Curb Ramps)

Main Street: SYLVANOAK\_WAY Cross Street: MARSTON\_LN Location: S

ADA ID: RPRK211115121421 Ramp Type: Type 4 - Parallel Initial Pass/Fail: Fail Overall Compliance: No Severity Score: 2

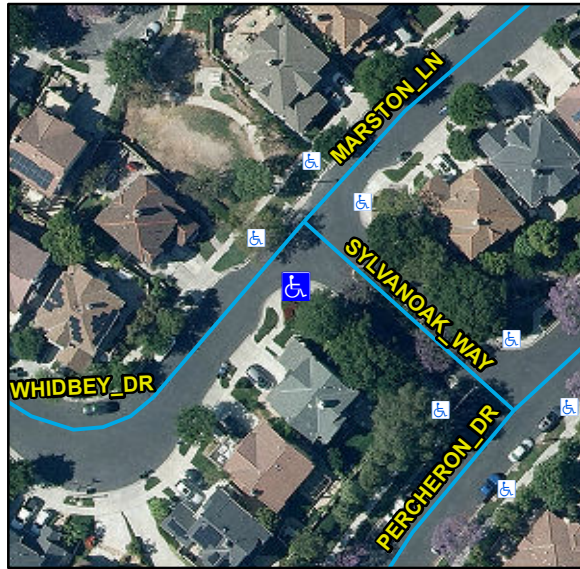
| Compliance | Description | Data | Compliance | Description | Data |
|---|---|---|---|---|---|
| Yes | Ramp Cross Slope LT (%) | 1.8 | No | Ramp Cross Slope RT (%) | 3.7 |

Remove & Replace Curb Ramp With Two New Directional Ramps or Equivalent.

R204.3, R304.5.3, STD 1115
