# Access Compliance Report Public Rights-of-Way (Curb Ramps)

Main Street: MARSTON\_LN Cross Street: SYLVANOAK\_WAY Location: E

ADA ID: RPRK211115121759 Ramp Type: Type 4 - Parallel Initial Pass/Fail: Pass Overall Compliance: No Severity Score: 25

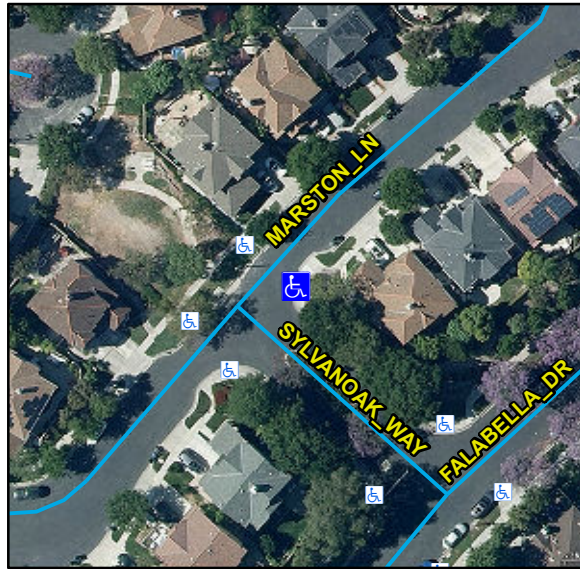
| Compliance | Description | Data | Compliance | Description | Data |
|---|---|---|---|---|---|
| N/A | Landing Present | No | No | DWS Provided | No |
| No | Landing Width (in) | N/A | N/A | DWS Length (in) | N/A |
| No | Landing Run Slope (%) | N/A | N/A | DWS Full Width | N/A |
| No | Landing Cross Slope (%) | N/A | | DWS Offset Type | N/A |
| No | Gutter Run Slope (%) | 12.7 | | Road Cross Slope (%) | 1.7 |
| No | Gutter Cross Slope (%) | 6.9 | No | Perpendicular Joint Present | No |

Remove & Replace Curb Ramp With Two New Directional Ramps or Equivalent. Remove & Replace Gutter.
