# Access Compliance Report Public Rights-of-Way (Curb Ramps)

Main Street: **NARROW\_CANYON\_RD** Cross Street: **N/A** Location: **NE**

ADA ID: **RPRK211115125045** Ramp Type: **Type 4 - Parallel** Initial Pass/Fail: **Fail** Overall Compliance: **No** Severity Score: **2**

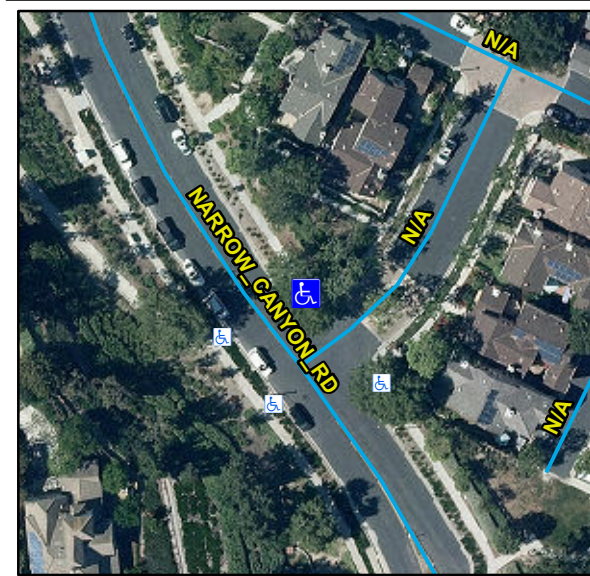
| Compliance | Description | Data | Compliance | Description | Data |
|---|---|---|---|---|---|
| <b>No</b> | Ramp Cross Slope LT (%) | <b>2.5</b> | <b>No</b> | Ramp Cross Slope RT (%) | <b>4.4</b> |

**Remove & Replace Curb Ramp With Two New Directional Ramps or Equivalent.**

**R204.3, R304.5.3, STD 1115**

Total Cost: \$ **4000**
