# Access Compliance Report Public Rights-of-Way (Curb Ramps)

| Main Street: N/A | Cross Street: NARROW_CANYON_RD | Location: SE |

| ADA ID: RPRK211115125258 | Ramp Type: Type 4 - Parallel | Initial Pass/Fail: Fail | Overall Compliance: No | Severity Score: 16 |

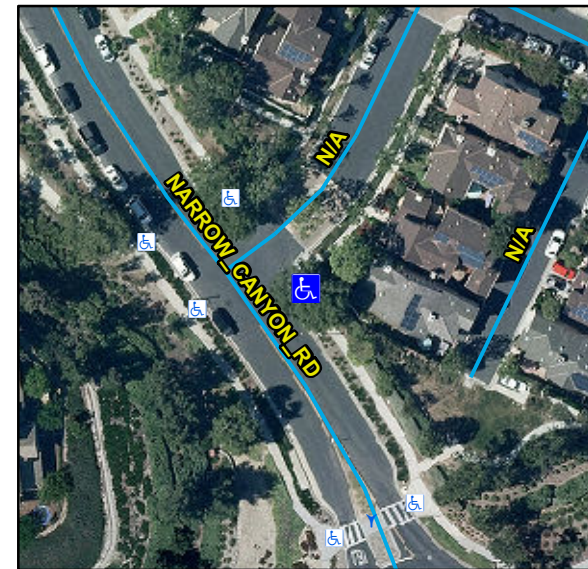
| Compliance | Description | Data | Compliance | Description | Data |
|---|---|---|---|---|---|
| No | Ramp Run Slope LT (%) | 11 | Yes | Ramp Run Slope RT (%) | 1.2 |
| Yes | Ramp Cross Slope LT (%) | 1.1 | No | Ramp Cross Slope RT (%) | 2.5 |

Possible Solutions:  
**Remove & Replace Curb Ramp With Two New Directional Ramps or Equivalent.**

OC Std/PROW:  
**R204.3, R304.3.2, R304.5.3, STD 1115**

Total Cost: \$ 4000
