# Access Compliance Report Public Rights-of-Way (Curb Ramps)

Main Street: N/A Cross Street: NARROW\_CANYON\_RD Location: SE

ADA ID: RPRK211115130711 Ramp Type: Type 4 - Parallel Initial Pass/Fail: Fail Overall Compliance: No Severity Score: 30

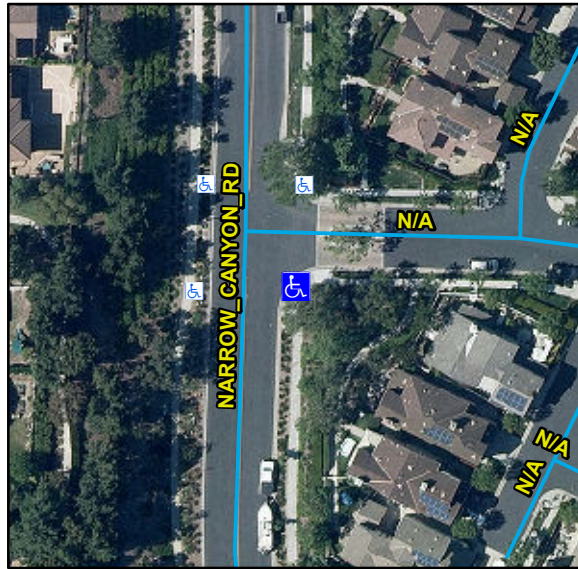
| Compliance | Description | Data | Compliance | Description | Data |
|---|---|---|---|---|---|
| No | Ramp Run Slope LT (%) | 12.3 | Yes | Ramp Run Slope RT (%) | 3 |

Remove & Replace Curb Ramp With Two New Directional Ramps or Equivalent.

R204.3, R304.3.2, STD 1115
