# Access Compliance Report Public Rights-of-Way (Curb Ramps)

| Main Street: <b>NARROW_CANYON_RD</b> | | Cross Street: <b>N/A</b> | | Location: <b>NE</b> |
| ADA ID: <b>RPRK211115130915</b> | Ramp Type: <b>Type 4 - Parallel</b> | Initial Pass/Fail: <b>Fail</b> | Overall Compliance: <b>No</b> | Severity Score: <b>2</b> |

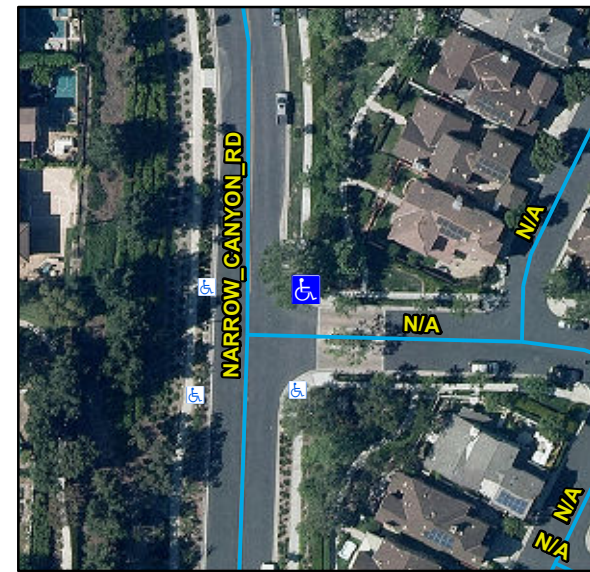
| Compliance | Description | Data | Compliance | Description | Data |
|---|---|---|---|---|---|
| <b>No</b> | Ramp Cross Slope LT (%) | <b>2.3</b> | <b>No</b> | Ramp Cross Slope RT (%) | <b>2.5</b> |

**Remove & Replace Curb Ramp With Two New Directional Ramps or Equivalent.**
