# Access Compliance Report Public Rights-of-Way (Curb Ramps)

| Main Street: N/A | Cross Street: NARROW_CANYON_RD | Location: SE |

| ADA ID: RPRK211115131420 | Ramp Type: Type 4 - Parallel | Initial Pass/Fail: Fail | Overall Compliance: No | Severity Score: 2 |

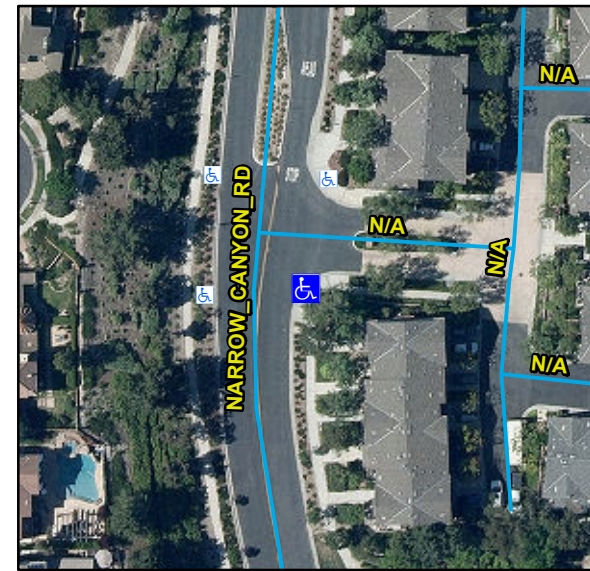
| Compliance | Description | Data | Compliance | Description | Data |
|---|---|---|---|---|---|
| No | Ramp Cross Slope LT (%) | 2.8 | No | Ramp Cross Slope RT (%) | 2.4 |

Remove & Replace Curb Ramp With Two New Directional Ramps or Equivalent.

R204.3, R304.5.3, STD 1115

Total Cost: \$ 4000
