# Access Compliance Report Public Rights-of-Way (Curb Ramps)

| Main Street: <b>NARROW_CANYON_RD</b> | | Cross Street: <b>N/A</b> | | Location: <b>NE</b> |
| ADA ID: <b>RPRK211115131707</b> | Ramp Type: <b>Type 4 - Parallel</b> | Initial Pass/Fail: <b>Fail</b> | Overall Compliance: <b>No</b> | Severity Score: <b>15</b> |

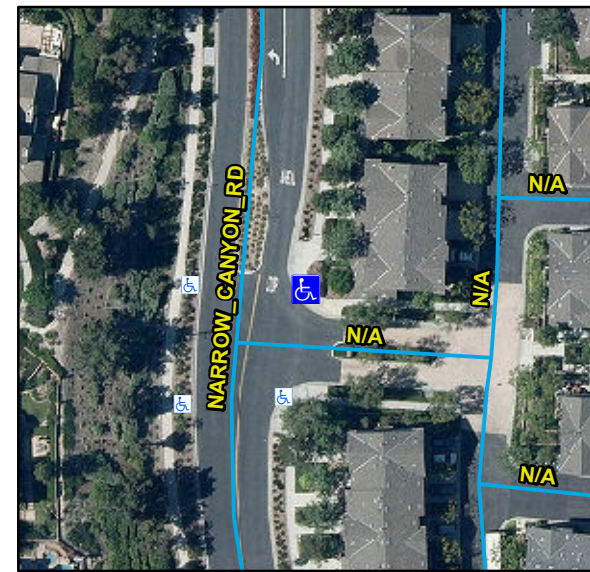
| Compliance | Description | Data | Compliance | Description | Data |
|---|---|---|---|---|---|
| <b>No</b> | Ramp Run Slope LT (%) | <b>11.1</b> | <b>Yes</b> | Ramp Run Slope RT (%) | <b>2.3</b> |

**Remove & Replace Curb Ramp With Two New Directional Ramps or Equivalent.**

**R204.3, R304.3.2, STD 1115**

Total Cost: \$ **4000**
