# Access Compliance Report Public Rights-of-Way (Curb Ramps)

| Main Street: FOLLATE_WAY | | Cross Street: FALLOW_LN | | Location: | SW |
| ADA ID: RPRK211115132154 | Ramp Type: Type 4 - Parallel | Initial Pass/Fail: Fail | Overall Compliance: No | Severity Score: | 16 |

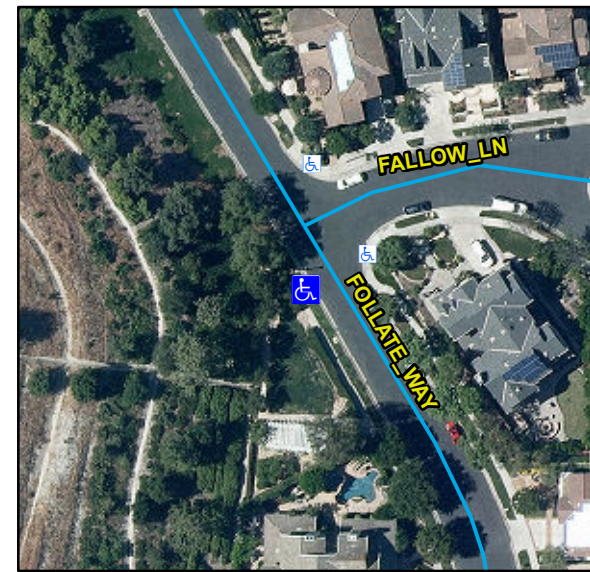
| Compliance | Description | Data | Compliance | Description | Data |
|---|---|---|---|---|---|
| Yes | Ramp Run Slope LT (%) | 4.2 | No | Ramp Run Slope RT (%) | 10.1 |
| No | Ramp Cross Slope LT (%) | 2.4 | No | Ramp Cross Slope RT (%) | 3.1 |

Possible Solutions:

Remove & Replace Entire Ramp.

R304.5.3, R304.3.2, STD 1115

Total Cost: \$ 2000
