# Access Compliance Report Public Rights-of-Way (Curb Ramps)

Main Street: BENJAMIN\_DR Cross Street: THORNHILL\_ST Location: S

ADA ID: RPRK211115134110 Ramp Type: Type 1 - Perpendicular Diagonal Initial Pass/Fail: Fail Overall Compliance: No Severity Score: 45

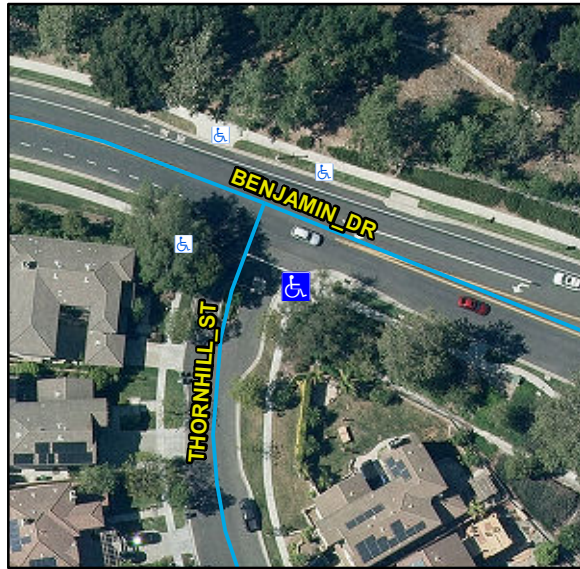
| Compliance | Description | Data | Compliance | Description | Data |
|---|---|---|---|---|---|
| No | Ramp Run Slope (%) | 9.6 | N/A | Flare Slope LT (%) | N/A |
| No | Ramp Cross Slope (%) | 10.1 | N/A | Flare Traversable LT | N/A |

Remove & Replace Curb Ramp With Two New Directional Ramps or Equivalent.
