# Access Compliance Report Public Rights-of-Way (Curb Ramps)

Main Street: CORPORATE\_DR Cross Street: TERRACE\_RD Location: SW

ADA ID: RPRK211115161125 Ramp Type: Type 4 - Parallel Initial Pass/Fail: Fail Overall Compliance: No Severity Score: 16

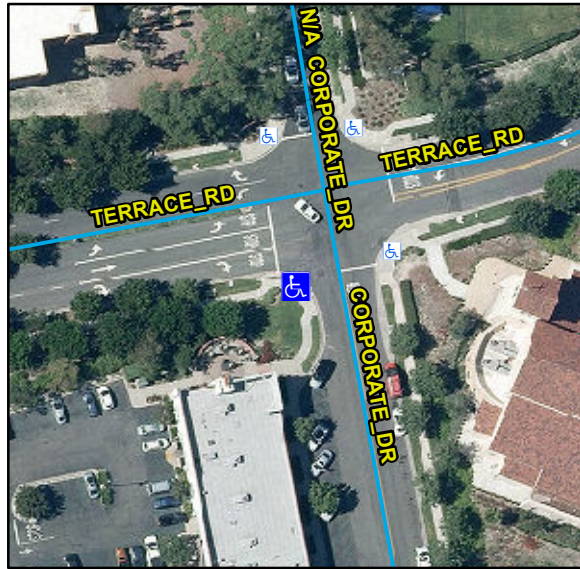
| Compliance | Description | Data | Compliance | Description | Data |
|---|---|---|---|---|---|
| No | Ramp Run Slope LT (%) | 10.8 | Yes | Ramp Run Slope RT (%) | 0.7 |
| No | Ramp Cross Slope LT (%) | 3 | Yes | Ramp Cross Slope RT (%) | 1.4 |

Remove & Replace Curb Ramp With Two New Directional Ramps or Equivalent.

R204.3, R304.3.2, R304.5.3, STD 1115
